Devil's Slide/Hwy 1 Storm Repair

Daily Updates from Bijan Sartipi

Daily Update
June 23

Devil's Slide (post mile 39.14)

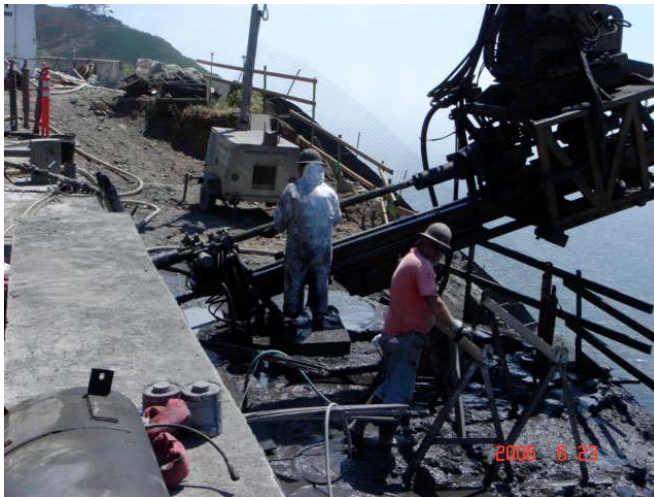
- Whaler wall 'A' (upper level ocean side) – drilling with reach over rig continued. 56 of 59 tie backs now installed. Tie back stressing continues.

Reach over rig drilling at wall A

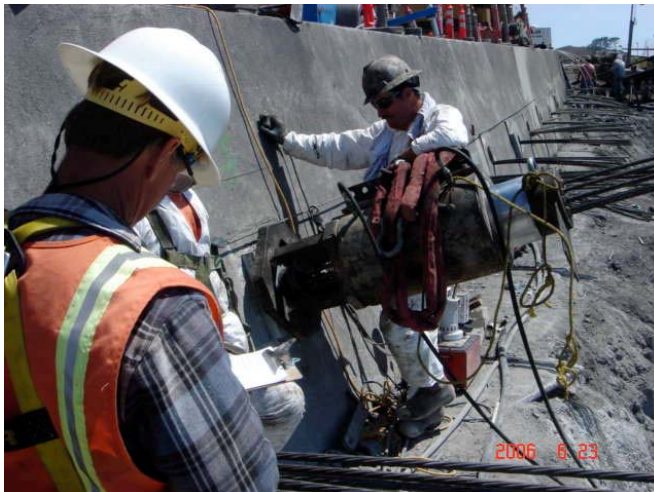
Stressing wall A tie backs

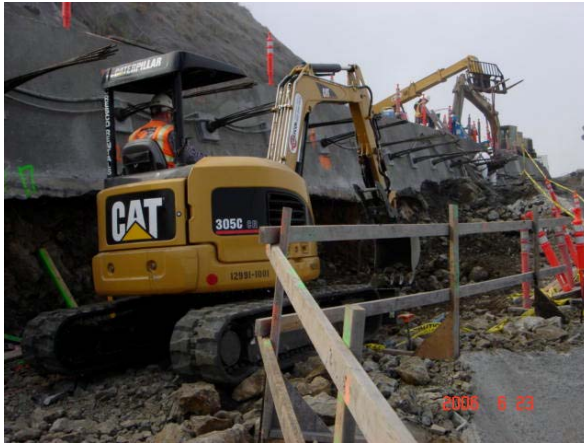
- Whaler wall 'B' (lower level ocean side) – Excavation work continues and rebar installation started.

Excavating a bench at wall B

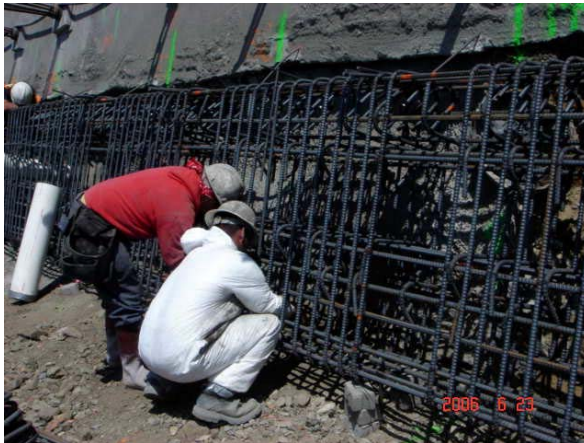
Rebar work for wall B

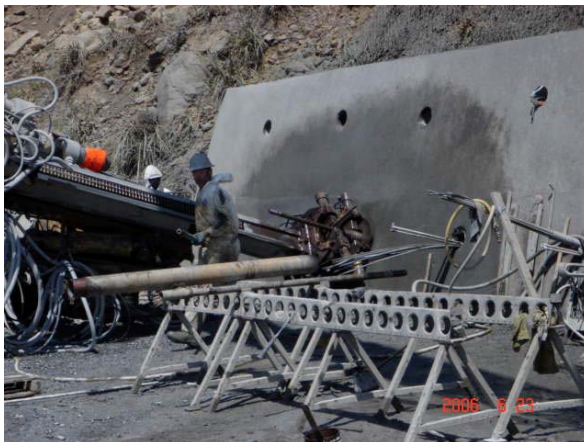
- Whaler wall 'C' (lower level cliff side) – drilling continued. 30 of 34 tie backs now installed.

Drilling at wall C
